Technical Color Quality Report

Job Name	Inspection Date	Inspection Time
Bridge kit	08/22/2023	11:29 am
Report Number	**Instrument Used**	**Performed By**
Z13ttrg	Spectro One Pro - 7084A C

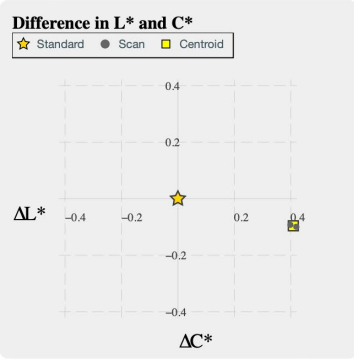
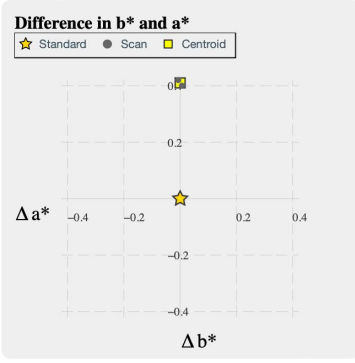
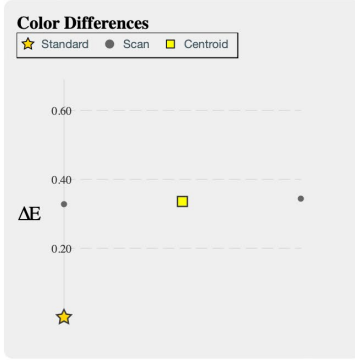
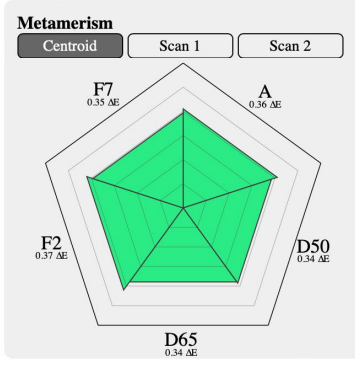
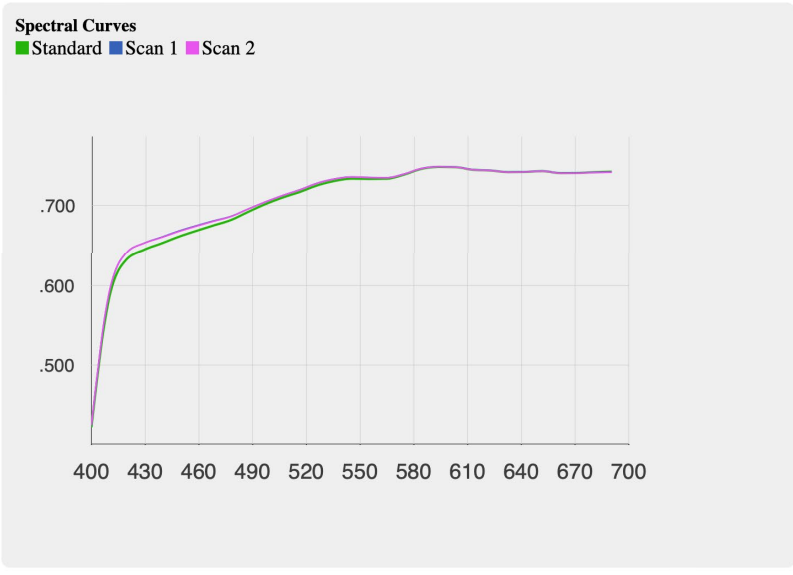
PASS

Part #	Part Name	Assigned Color	Scan Count	Tolerance (ΔE2000)	Measured Tolerance
1	White tile	Scanned Color	2	2.25	0.336

type	L	a	b	Color Space	Tolerance
Centroid	88.34	-0.44	5.23	D65 / 10°	0.336
Standard	88.24	-0.44	5.64	D65 / 10°	0.000
Scan 1	88.34	-0.44	5.22	D65 / 10°	0.344
Scan 2	88.33	-0.45	5.24	D65 / 10°	0.328

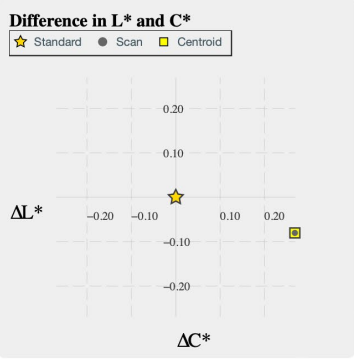
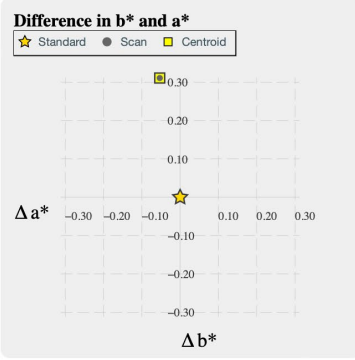
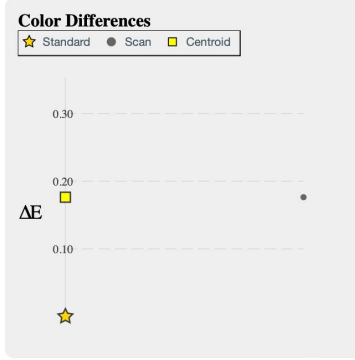
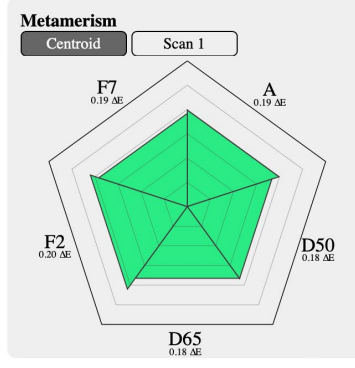
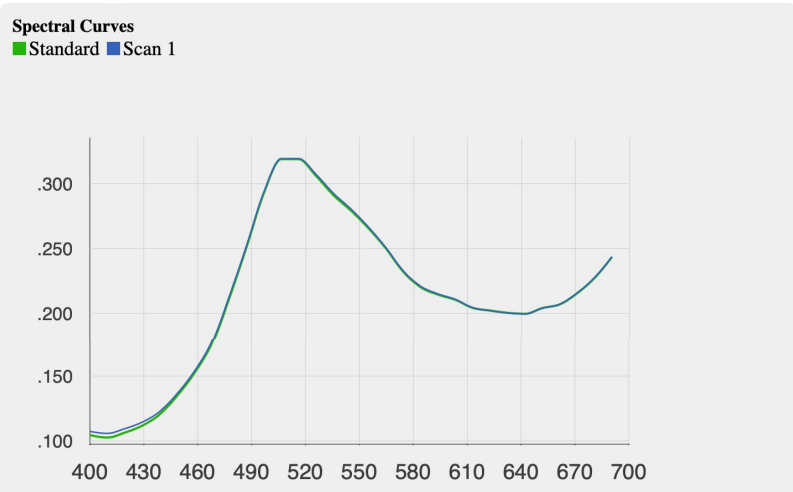
PASS

Part #	Part Name	Assigned Color	Scan Count	Tolerance (ΔE2000)	Measured Tolerance
2	Green tile	Scanned Color	1	2.25	0.176

type	L	a	b	Color Space	Tolerance
Centroid	57.75	-18.01	20.31	D65 / 10°	0.176
Standard	57.67	-18.07	20.62	D65 / 10°	0.000
Scan 1	57.75	-18.01	20.31	D65 / 10°	0.176

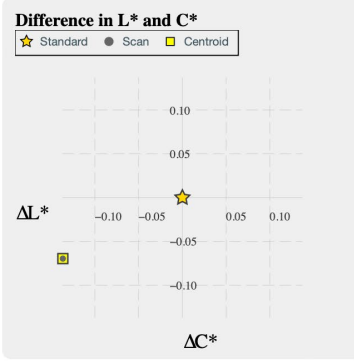
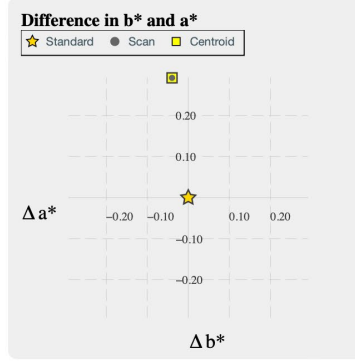
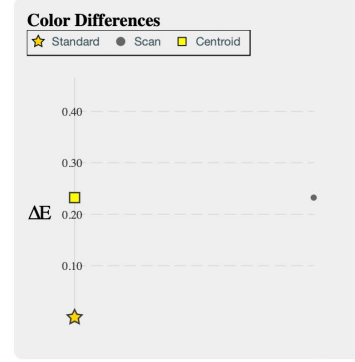
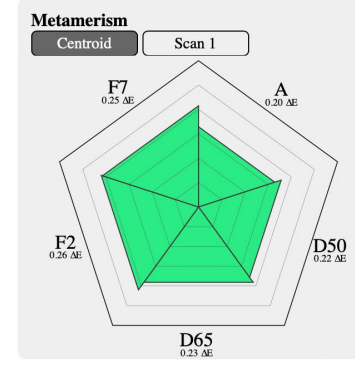
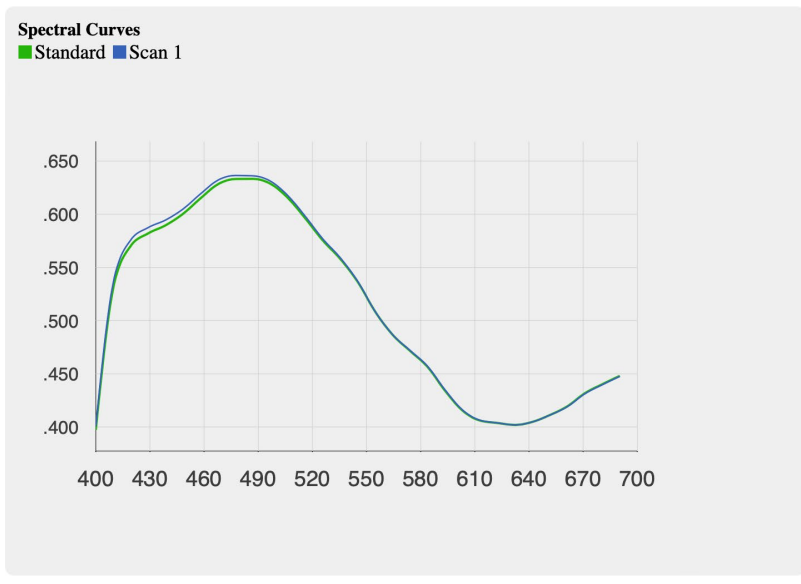
PASS

Part #	Part Name	Assigned Color	Scan Count	Tolerance (ΔE2000)	Measured Tolerance
3	Blue tile	Scanned Color	1	2.25	0.233

type	L	a	b	Color Space	Tolerance
Centroid	77.77	-10.40	-7.56	D65 / 10°	0.233
Standard	77.70	-10.44	-7.27	D65 / 10°	0.000
Scan 1	77.77	-10.40	-7.56	D65 / 10°	0.233

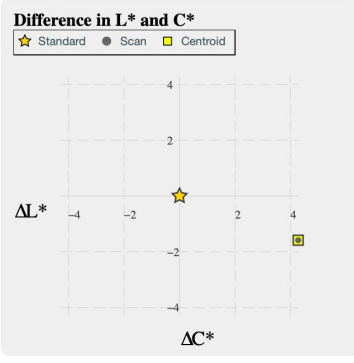
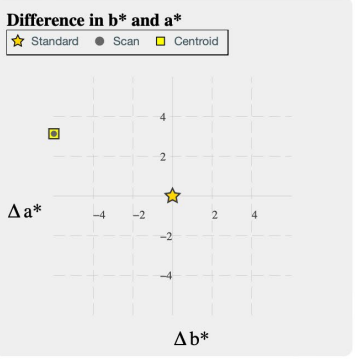
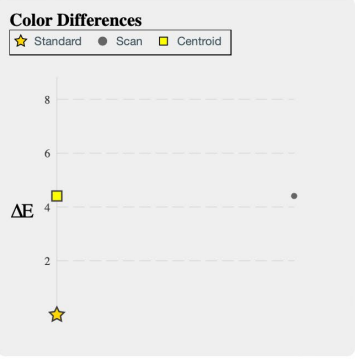
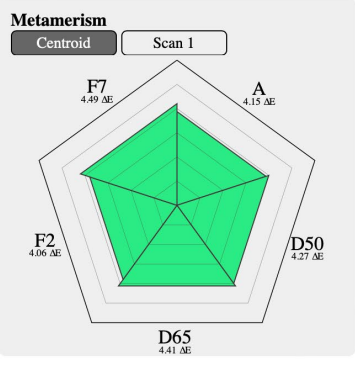
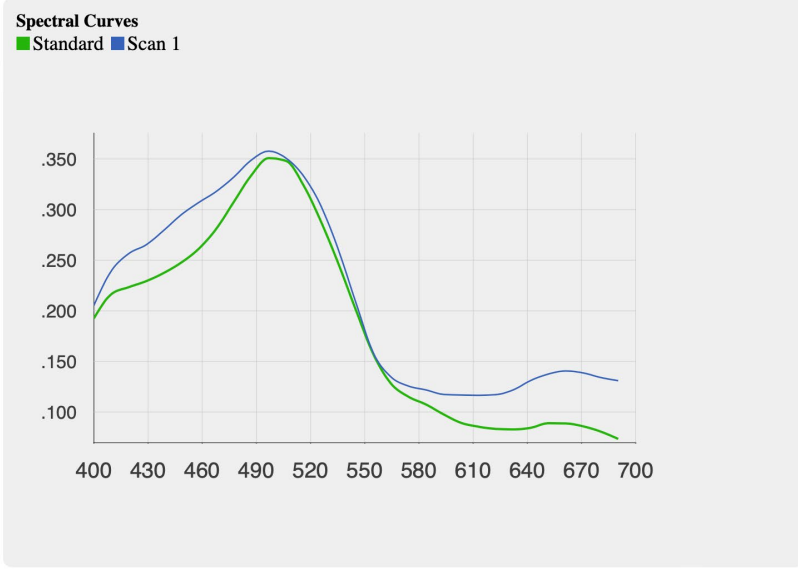
WARN

Part #	Part Name	Assigned Color	Scan Count	Tolerance (ΔE2000)	Measured Tolerance
4	Instructions	Scanned Color	1	9	4.408

type	L	a	b	Color Space	Tolerance
Centroid	53.96	-23.04	-12.63	D65 / 10°	4.408
Standard	52.37	-29.03	-9.49	D65 / 10°	0.000
Scan 1	53.96	-23.04	-12.63	D65 / 10°	4.408
